INDOOR AIR QUALITY ASSESSMENT

**Department of Revenue
60 Perseverance Way
Hyannis, MA**

Prepared by:
Massachusetts Department of Public Health
Bureau of Environmental Health
Indoor Air Quality Program
August 2017

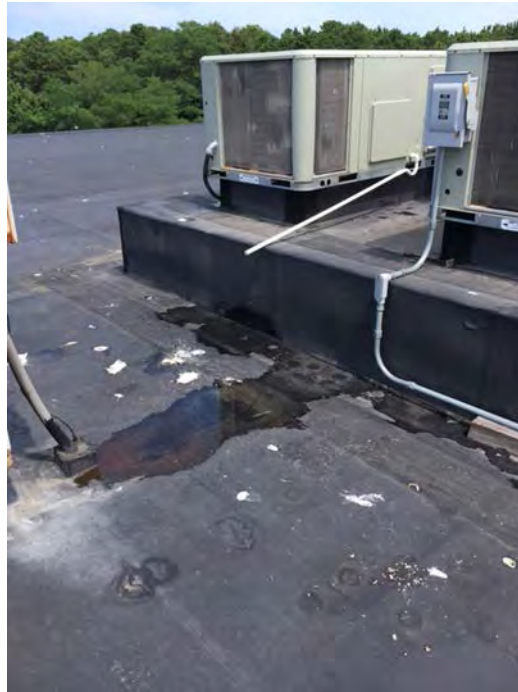
Picture 1

Fresh air is provided by air handling units (AHUs) located on the roof (Picture 1). Air from the AHUs is filtered, heated/cooled, and delivered to rooms via ducted supply vents (Picture 2). Air is returned/exhausted through exhaust grills. Some thermostats examined were operating in fan “auto” mode (Picture 3) which only supplies fresh air when the temperature needs adjustment. It is recommended that during occupied periods, the HVAC system be operated with the fan “on.” As was also noted in the April 2017 report, some thermostats are not set to the correct time, which can cause problems with settings for occupied versus unoccupied periods.

This visit was conducted in response to concerns about flying insects identified as gnats by the occupants. Although cleaning had reportedly been conducted, some insect residue was observed in the area of concern (Pictures 4). The source of the insects was traced to the roof where water was observed pooling next to the AHU (Picture 1). The source of water in this area is a combination of rainwater and condensate from the operation of the AHU in cooling mode. Some of the water was observed to contain organic matter that appeared to be insect eggs (Picture 5). Seagull nesting material, fecal waste and feathers were also observed on the roof, including near the AHUs (Pictures 1 and 6).

Any insects hatching from this water, or other insects attracted to the roof by standing water and debris, can be drawn into the AHU fresh air vent. It also appeared that the filters inside the AHU were not fully flush with the casing, which can allow particulate matter and small flying insects to bypass the filter and be distributed to occupied spaces in the building. Another means of pest entry into the building would be through the condensate pipe, which is approximately three feet long (Picture 1). Extending this pipe would not only assist in drainage of condensate away from the AHU and off the roof, but would also be a barrier to pest entry. Consider installing one or more 90 degree bends in the pipe. The condensate drain pipe should maintain a properly designed “P trap” as recommended by the AHU manufacturer to further prevent pests as well as unconditioned air from entering the AHU.

Rooftop air handling unit, note pooling water, bird waste (white spots) and drain pipe

2. Extend the length of the condensate drainage pipe from the AHU to discharge water further away from the air intake of the AHU and provide a barrier to pests. Consider installing one or more 90 degree bends in the pipe. Be sure to maintain a properly designed “P trap” on the condensate drain pipe and adequate drainage as recommended by the AHU manufacturer.

3. Ensure that all filters are installed flush with the housings inside the AHU so that no bypass of insects or debris can occur. Inspect filters regularly and change in accordance with manufacturer’s instructions.

4. Periodically remove debris and water from the roof to prevent a build-up of bird waste, feathers and other organic debris that can be attractive to pests and be a source of mold and odors.

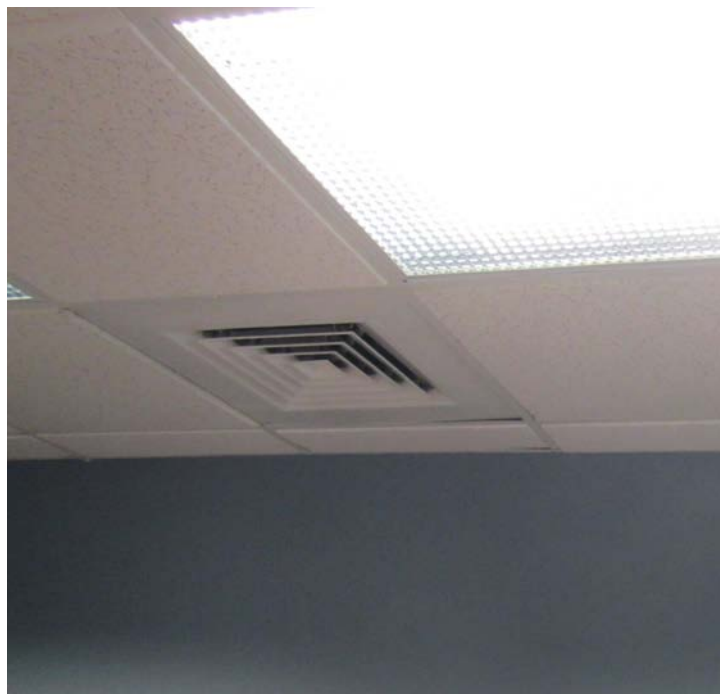
Picture 2

Personal fans were observed in a number of areas. Fan blades to some of these units had settled dust, which can be reaerosolized when the fan is activated. Some supply vents were also dusty (Picture 2).

Ceiling-mounted supply vent

18. Clean the blades of personal fans, supply, and exhaust vents periodically to avoid aerosolizing dusts.
19. Refer to resource manual and other related IAQ documents located on the MDPH's website for further building-wide evaluations and advice on maintaining public buildings. These documents are available at: <http://mass.gov/dph/iaq>.

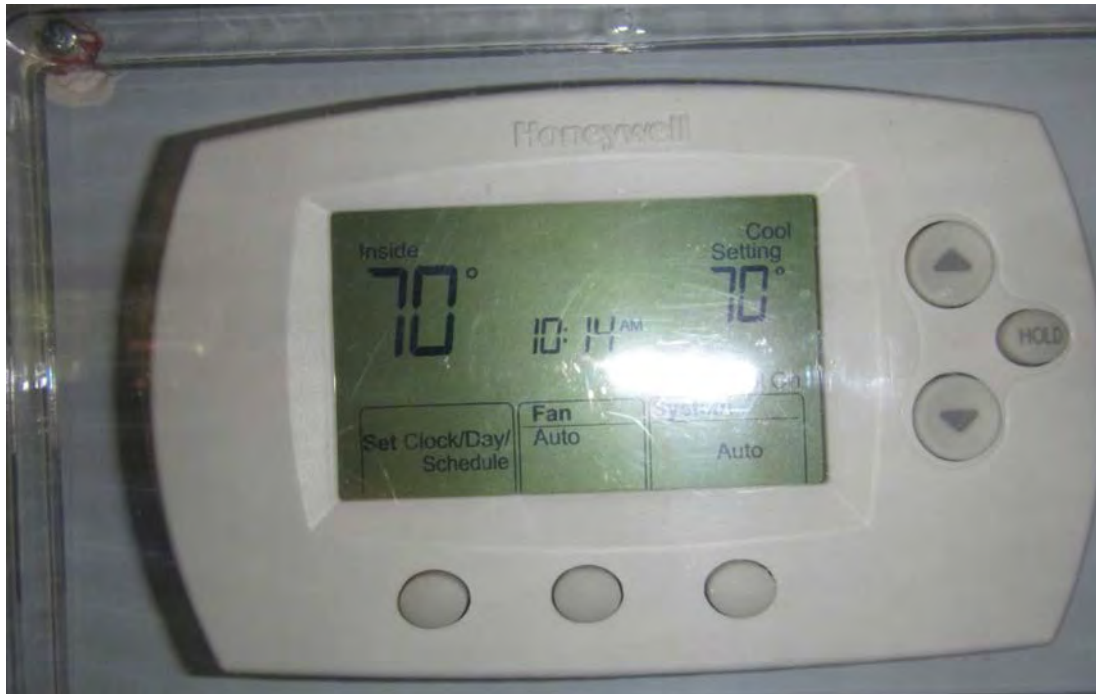
Picture 3

Thermostat, note “fan auto” mode

9. Operate supply and exhaust ventilation in all areas during occupied periods. Ensure that thermostats have the correct time to allow for adjustments for occupied versus unoccupied periods.

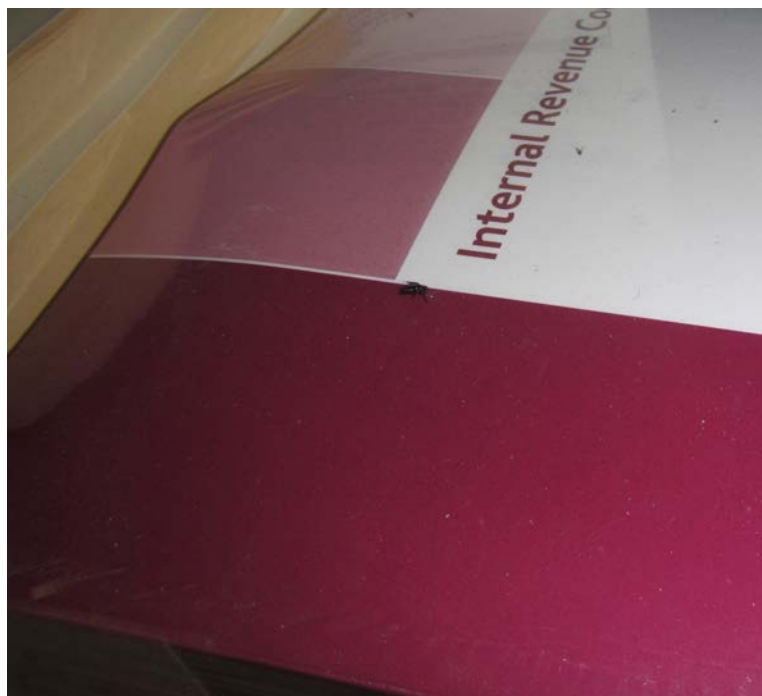
Picture 4

Dead insect on books

1. Use a larvicide in the standing water on the roof to control pests. Consult with a licensed pesticide applicator to identify an appropriate product for this use.

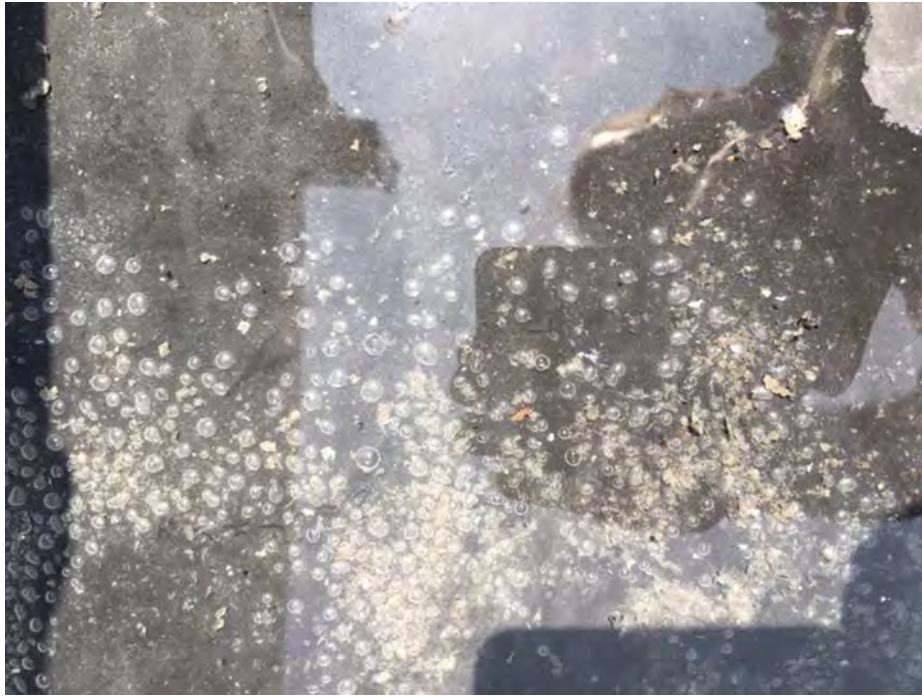
Picture 5

Water is pooling on the roof due to a lack of roof drains. Water can only drain from the roof via cut-outs (scuppers) in the parapet walls. Since the roof is not well pitched to the edges, there are areas which collect water. The slow trickle of condensate from the AHU during the cooling season provides a continual source of water to keep these pools moist allowing the propagation of insects. Continually moist organic waste/debris will also become mold-colonized.

Pooling water with organic debris that may be insect eggs/larva

5. Investigate means to improve drainage from the roof.

6. If roof drainage cannot be improved to eliminate standing water, consult with a licensed pesticide applicator regarding continued use of larvicidal tablets to treat the standing water.

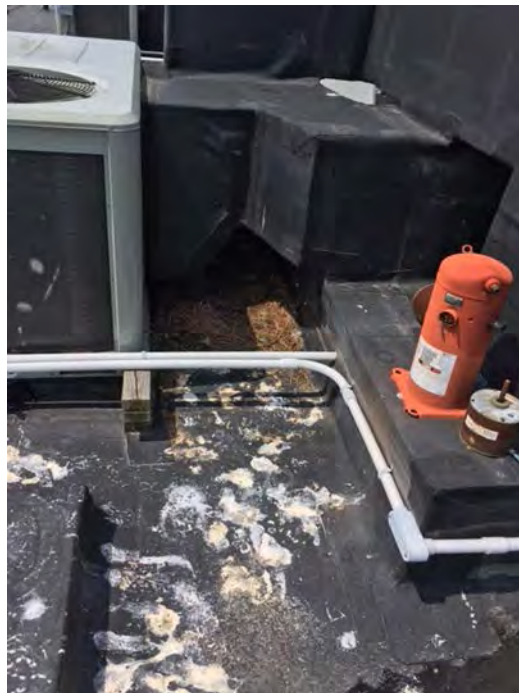
Picture 6

Bird waste, feathers, and debris near air handling units on the roof

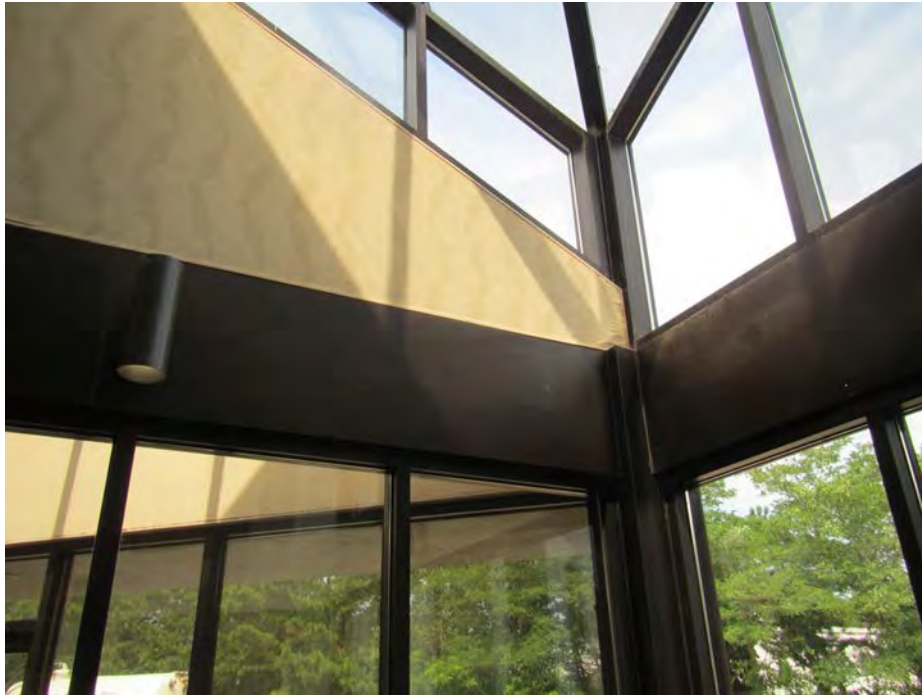
Picture 7

No water-damaged ceiling tiles were observed in offices during this visit. Some water damage to paint and wall/ceiling material was observed in the atrium, resulting from recent heavy rains in the area (Picture 7).

Water-damaged paint at corner of atrium

12. Repair water-damaged paint/wall in the atrium and monitor for additional leaks during wet weather.
13. Consider removing carpeting in sprinkler/janitorial closet to prevent water damage. Avoid storing porous materials in this area.

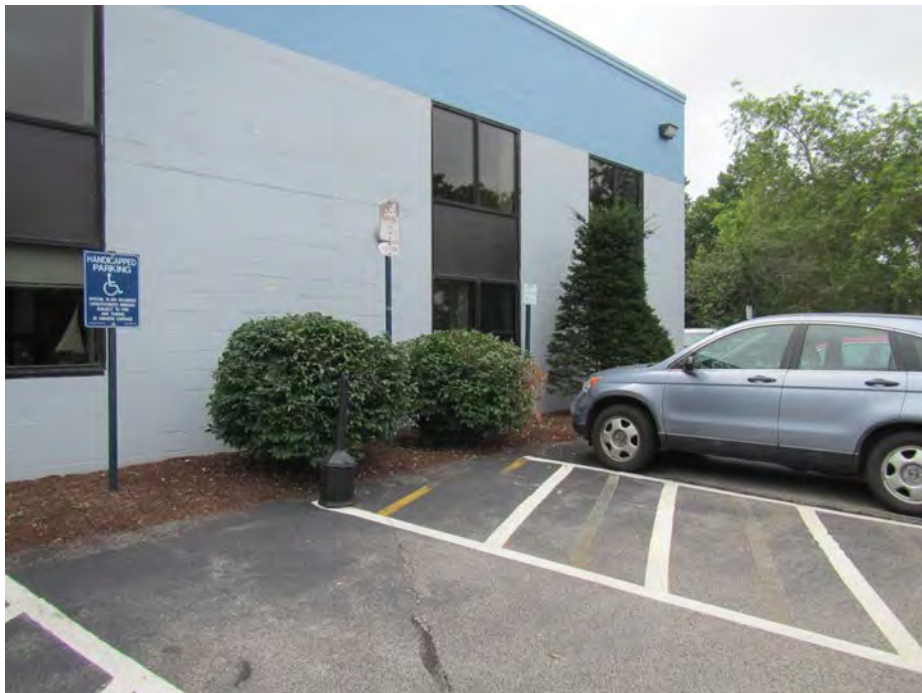
Picture 8

Mulch and plants were observed close to and in contact with the building and foundation (Pictures 8 and 9). Plants and mulch hold water against the foundation which will lead to deterioration of the building envelope and potential water penetration. Mulch can also be attractive to pests, including termites, which have reportedly been an issue with this building recently. Mulch should be removed and plants should be trimmed significantly away from the building.

Mulch and plants near the foundation/walls of the building

8. Remove mulch from the exterior foundation and trim plants to at least five feet away from the building exterior to reduce moisture held against the building envelope and discourage termites.

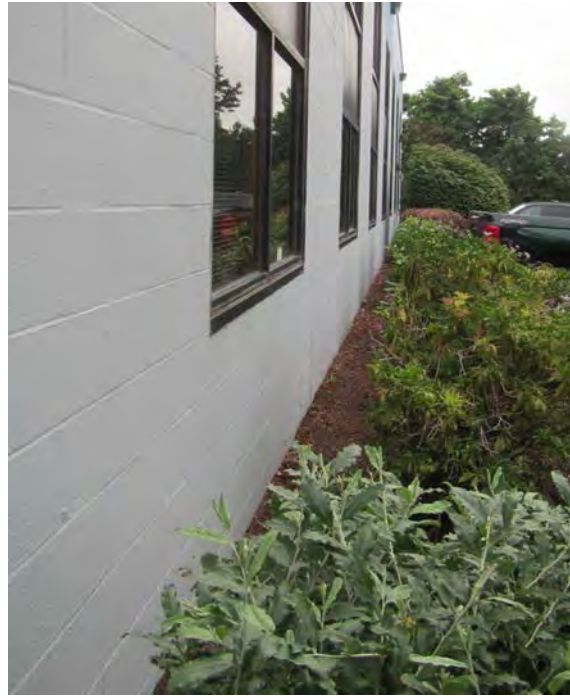
Picture 9

Shrubs and mulch next to the foundation

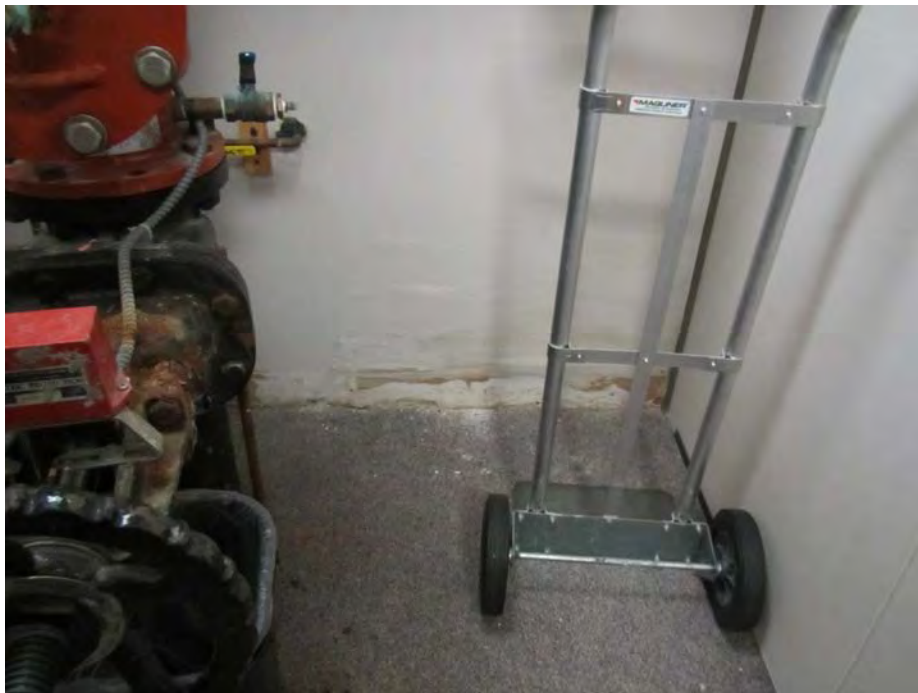
Picture 10

During the previous visit, water-damaged materials and likely mold colonization were observed inside a sprinkler/janitorial closet that opens to an occupied area. Since that visit, it appears that the base coving was removed as recommended in the previous report and the water-damaged gypsum wallboard had also been removed (Picture 10). Note, however, that the conditions in this room that led to water damage might reoccur, therefore the carpeting should probably be removed from the room and no porous materials (boxes and decorative items) should be stored there.

Removed coving and repaired wall in the sprinkler room, note carpeting
